FINAL PRELIMINARY ASSESSMENT REPORT FORMER WALKER AIR FORCE BASE ATLAS "F" MISSILE SILO 9 LINCOLN COUNTY, NEW MEXICO PROPERTY NO. K06NM0487

October 24, 2005

HydroGeoLogic, Inc. 340 East Palm Lane Suite 240 Phoenix, Arizona 85004

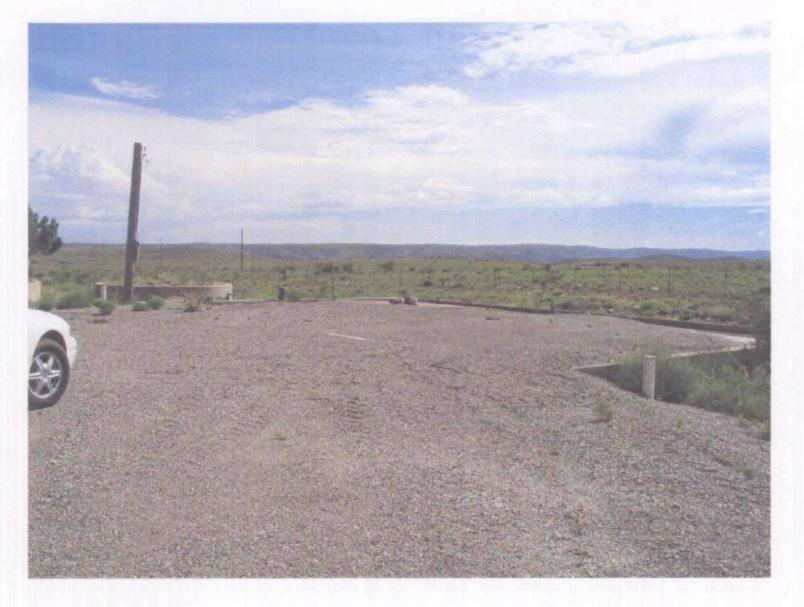
Photog	raph Number:
•	2
Date:	
•	August 2, 2004
Time:	
•	4:27 p.m.
Directi	on:
•	Southwest
Weath	er:
•	Partly Cloudy
Photog	rapher:
•	HydroGeoLogic, Inc.
Locatio	on:
•	Pad for Water Treatment
	Building

Foundations for the former Water Treatment Building and water storage tank are visible.

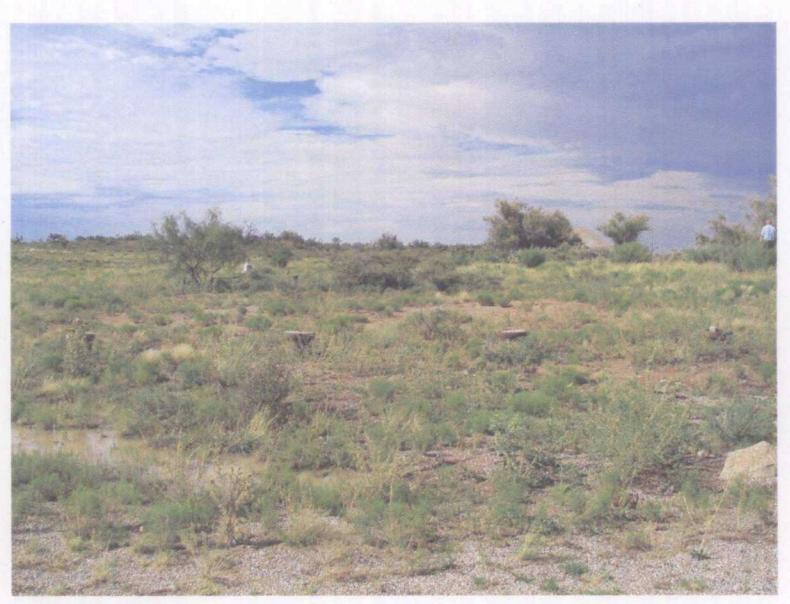
Photograph Number: . 3 Date: • August 2, 2004 Time: 4:27 p.m. • **Direction:** • Northeast Weather: • Cloudy Photographer: • HydroGeoLogic, Inc. Location: Leachfield .

Leachfield associated with the septic tank for the LCC sump. Dense vegetation and several vents are visible. The entry to the launch control center is visible in the background.

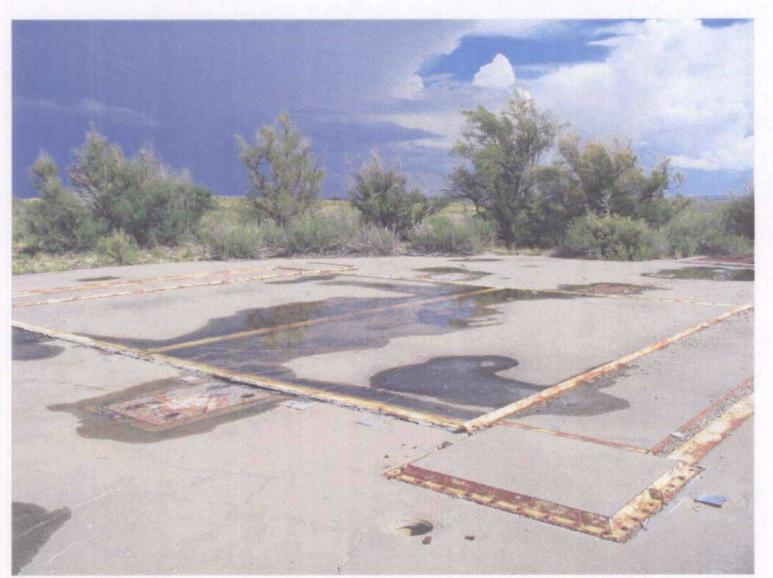
Photog	raph Number:	
•	4	
Date:		
•	August 2, 2004	
Time:		
•	4:29 p.m.	
Directi	on:	1
•	South	
Weath	er:	
•	Cloudy	
Photog	grapher:	
•	HydroGeoLogic, Inc.	
Locatio	on:	
•	Silo Pad

The silo pad remains intact with small cracks evident. This photograph depicts the silo doors that cover the underground silo complex. The area surrounding the silo pad is heavily vegetated. Rain from a recent storm is pooling on portions of the silo pad.
Appendix C

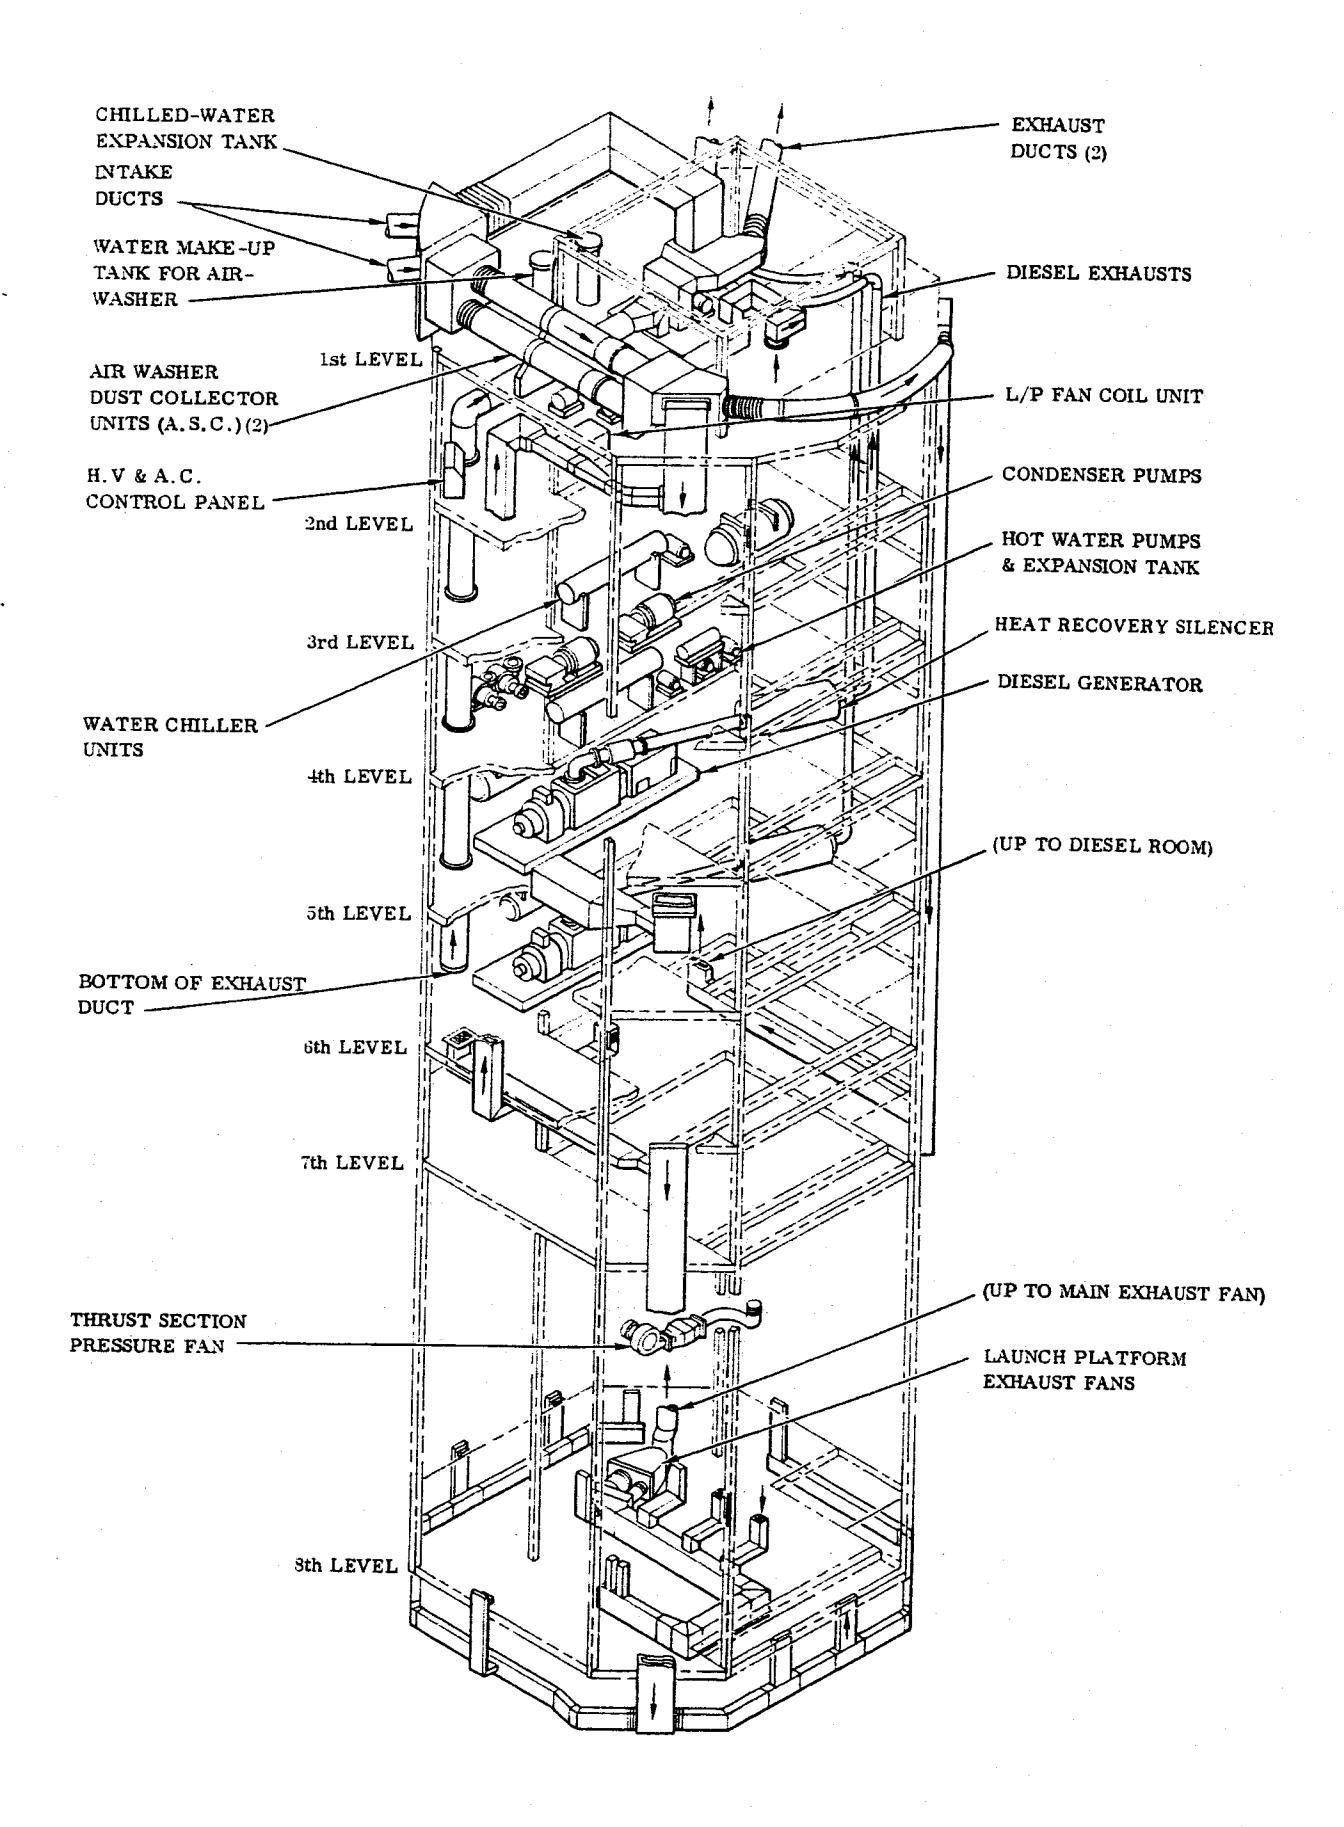
HEATING, VENTILATING AND AIR-CONDITIONING SYSTEM

This system continuously pumps a supply of fresh, washed air into the silo, heats or cools the air as required, and distributes it throughout the silo. Part of the system maintains constant temperature inside the shaft that encloses the launcher platform. The system also continuously expels stale air, fumes and vapors from the silo.

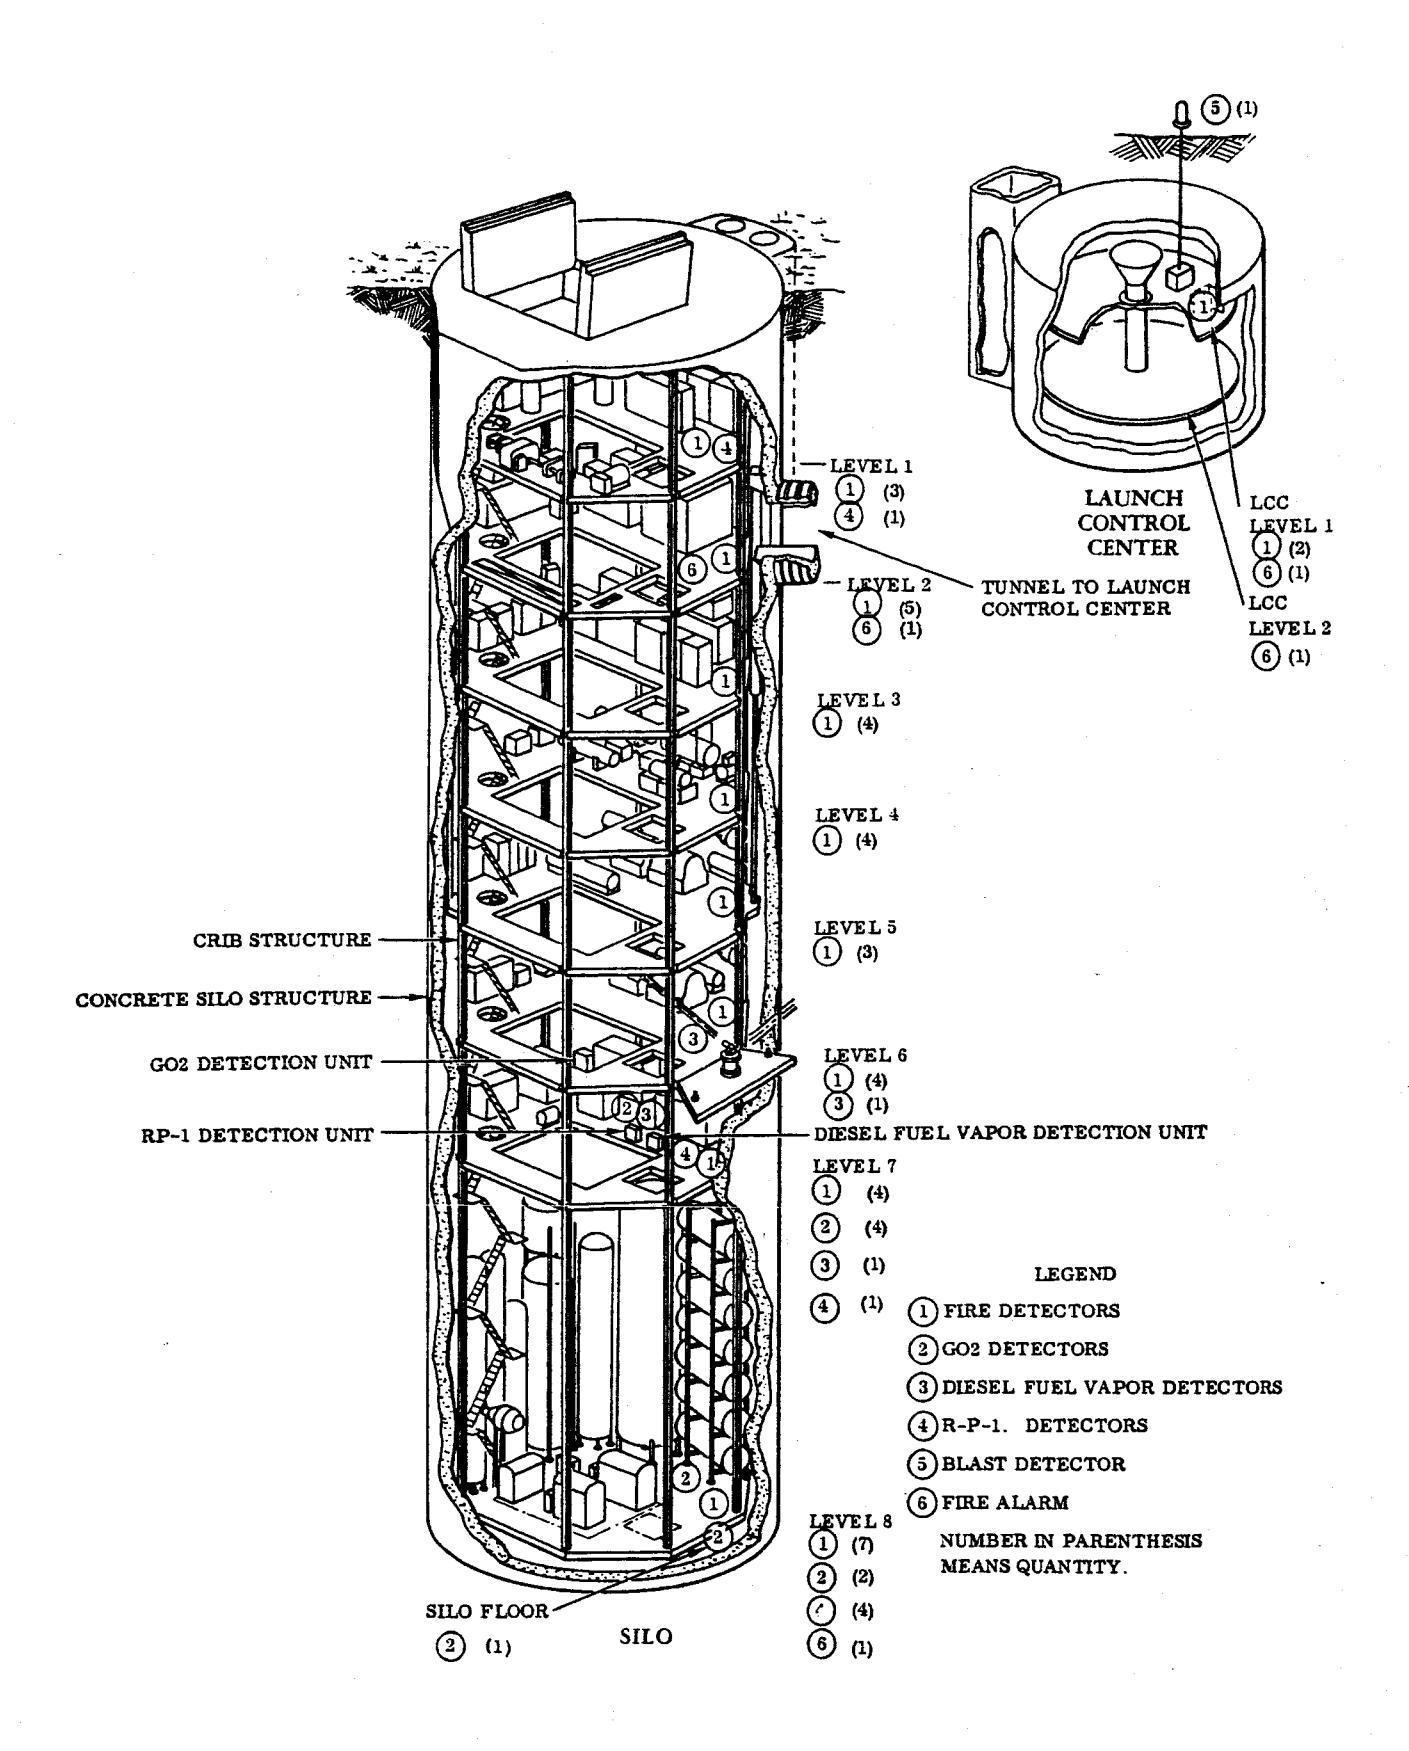
DETECTION SYSTEMS

There are five detection systems at each launch complex: the fire alarm system, which detects and provides alarm signals in the event of fire: the gaseous oxygen detection system and the diesel fuel vapor detection system. These systems give both a visual and an audible warning if they detect critical concentrations of gaseous oxygen or diesel fuel vapor in the silo. Another detection system senses the presence of missile fuel vapor in the silo, gives a visual and audible warning, and causes the release of water fog which suppresses the vapor. Fifth is the blast detection system: this system consists primarily of a light-sensitive detector, mounted above ground level at the launch complex, which is sensitive only to high-intensity light, such as the flash of a nuclear explosion. Upon sensing such a flash, the detector sends a signal to a cabinet in the launch control center. This signal closes blast protection doors in the ventilator ducts, and at other passages with openings at ground level, before the blast forces of the explosion.

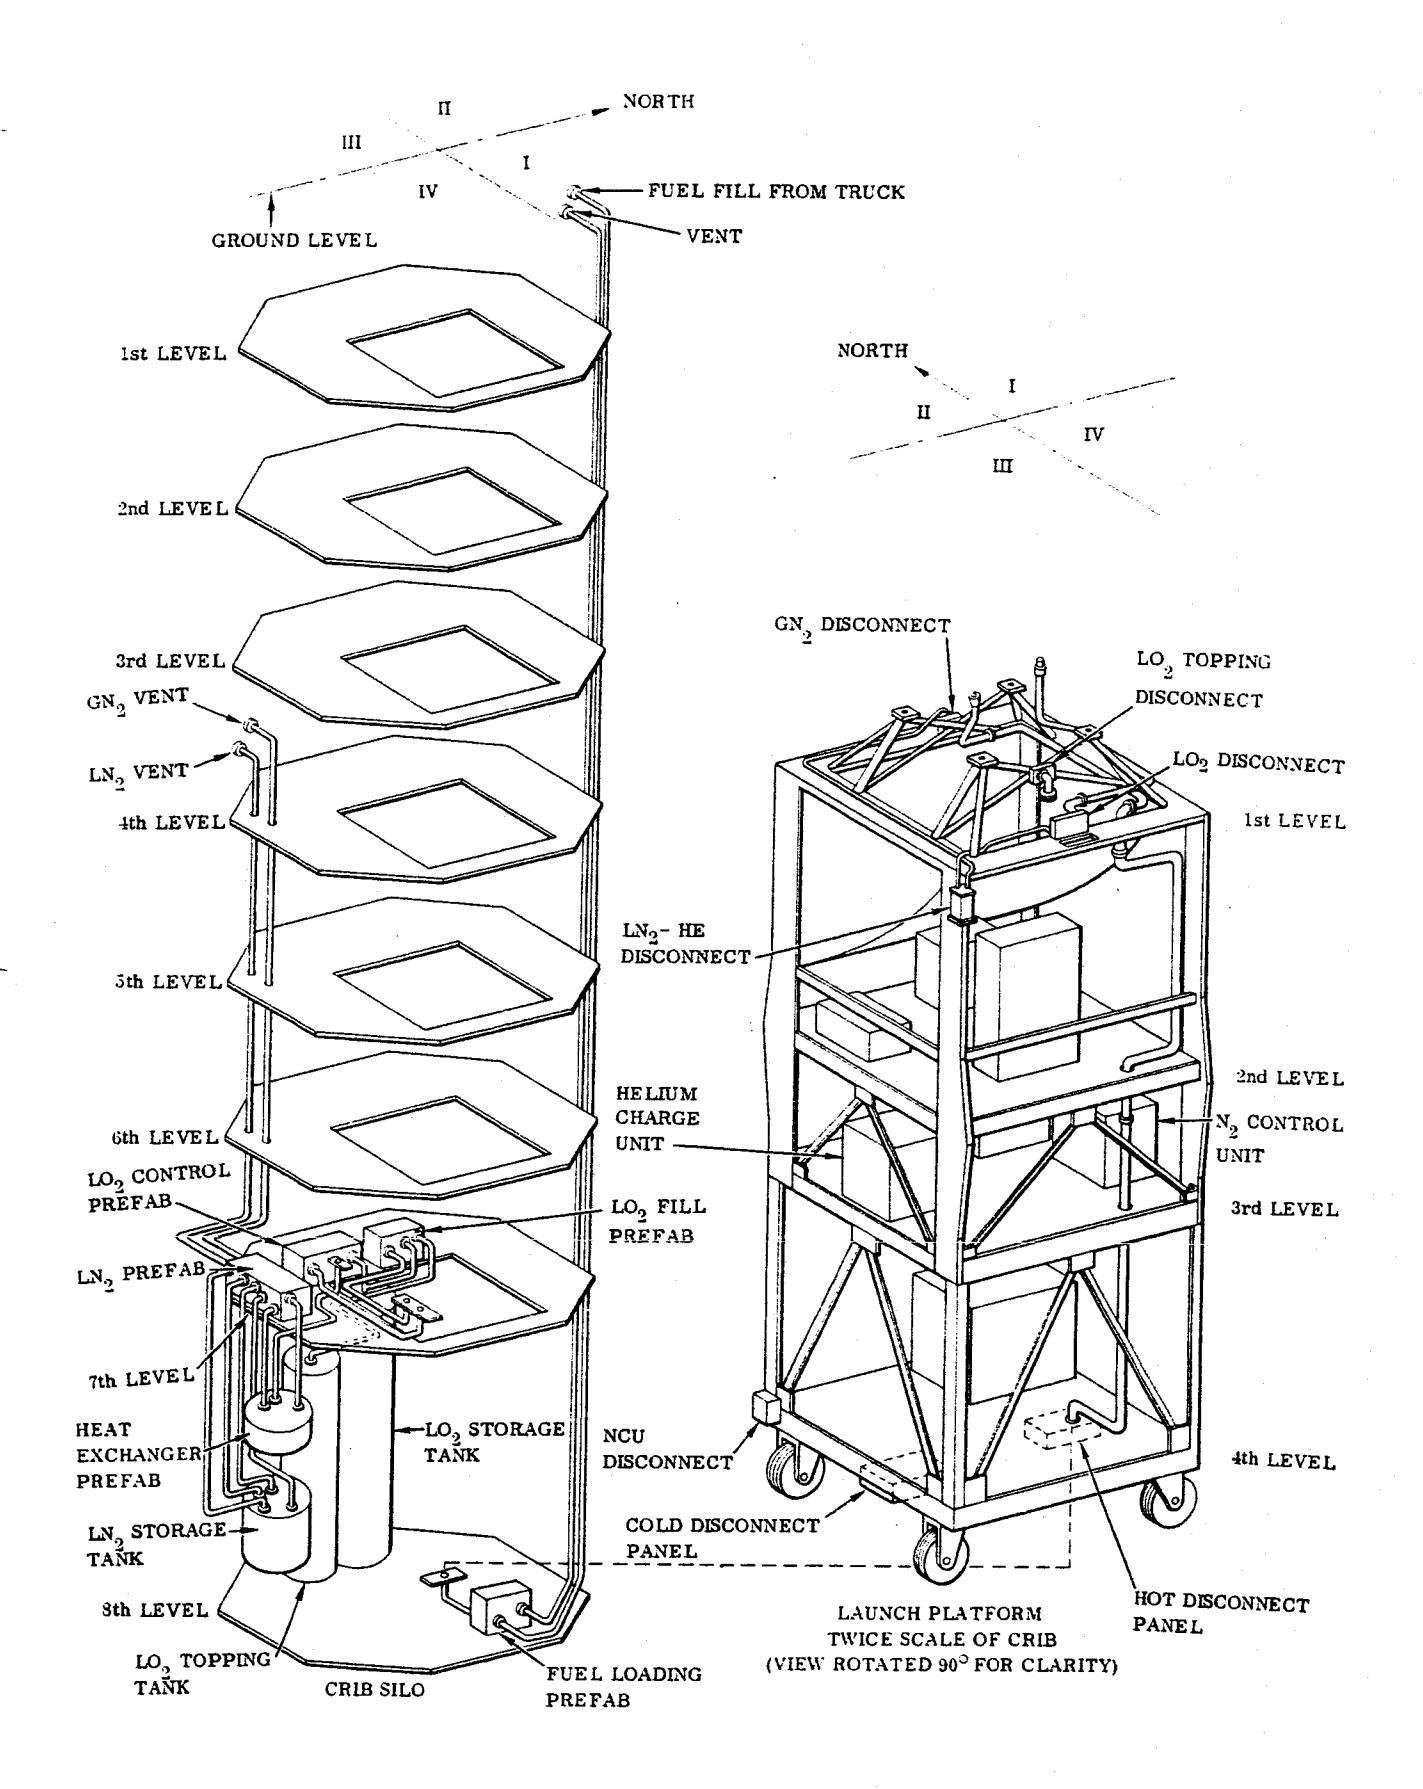
PROPELLANT LOADING SYSTEM

The propellant loading system consists of the silo-mounted storage tanks, control units and tubing which supply fuel and liquid oxygen to the missile (see illustration on opposite page). Fuel is loaded aboard the missile through fill lines connected to a tank truck above ground. The fuel then remains aboard the missile until the missile is launched or replaced. Two Dewar-type tanks in the system store liquid oxygen, which is transferred to the missile during countdown operations.

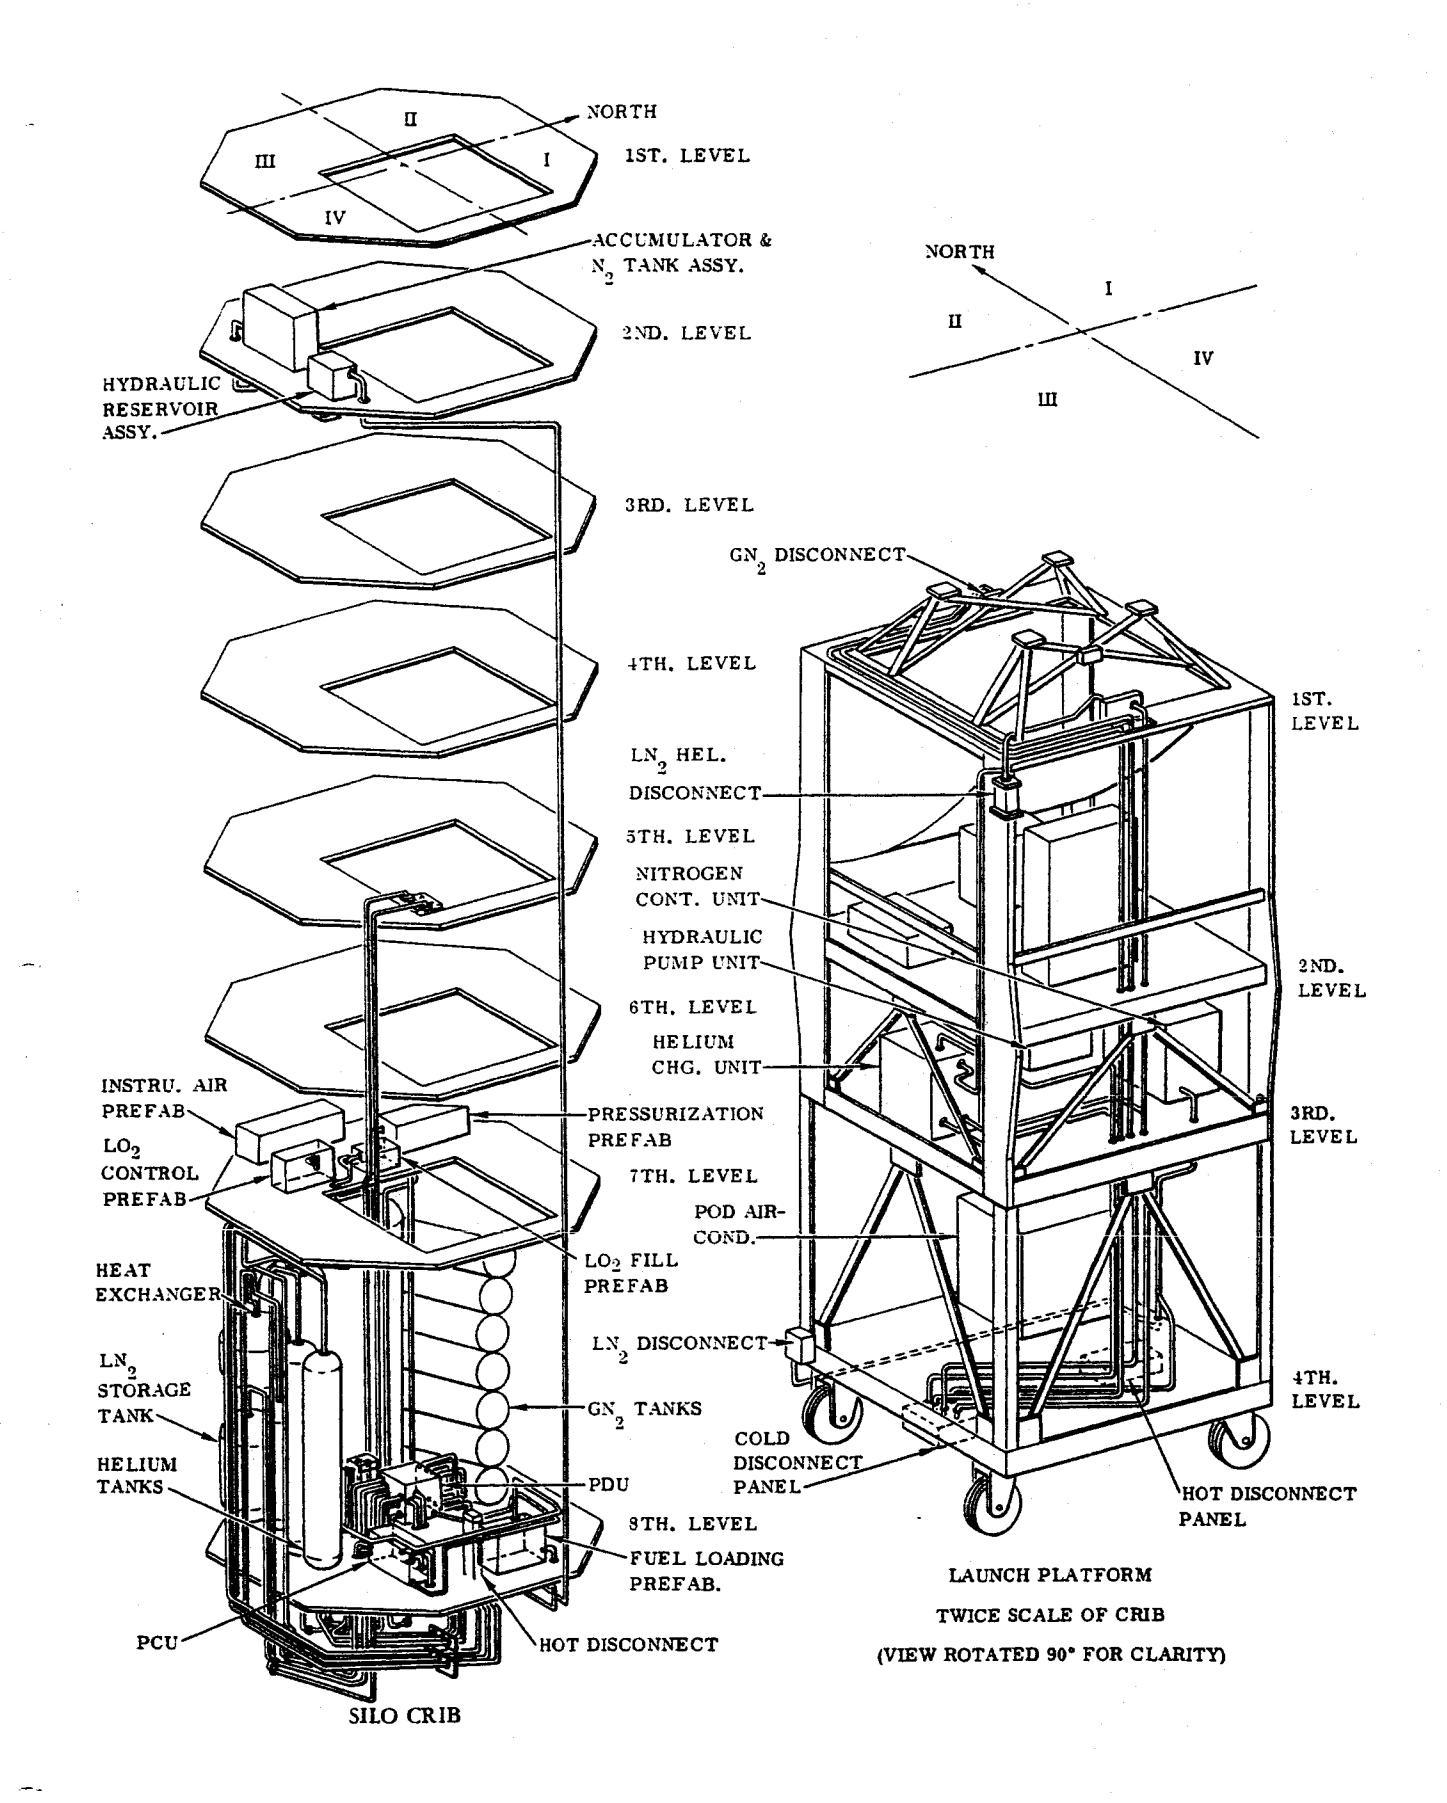
PNEUMATIC SYSTEM

The pneumatic system includes the silo-mounted equipment used in the storage, control and transfer of gases. (See illustration on opposite page.) Gaseous nitrogen handled is used in missile propellant transfer, silo hydraulic equipment operation, and missile maintenance. Helium is used for missile tank pressurization.

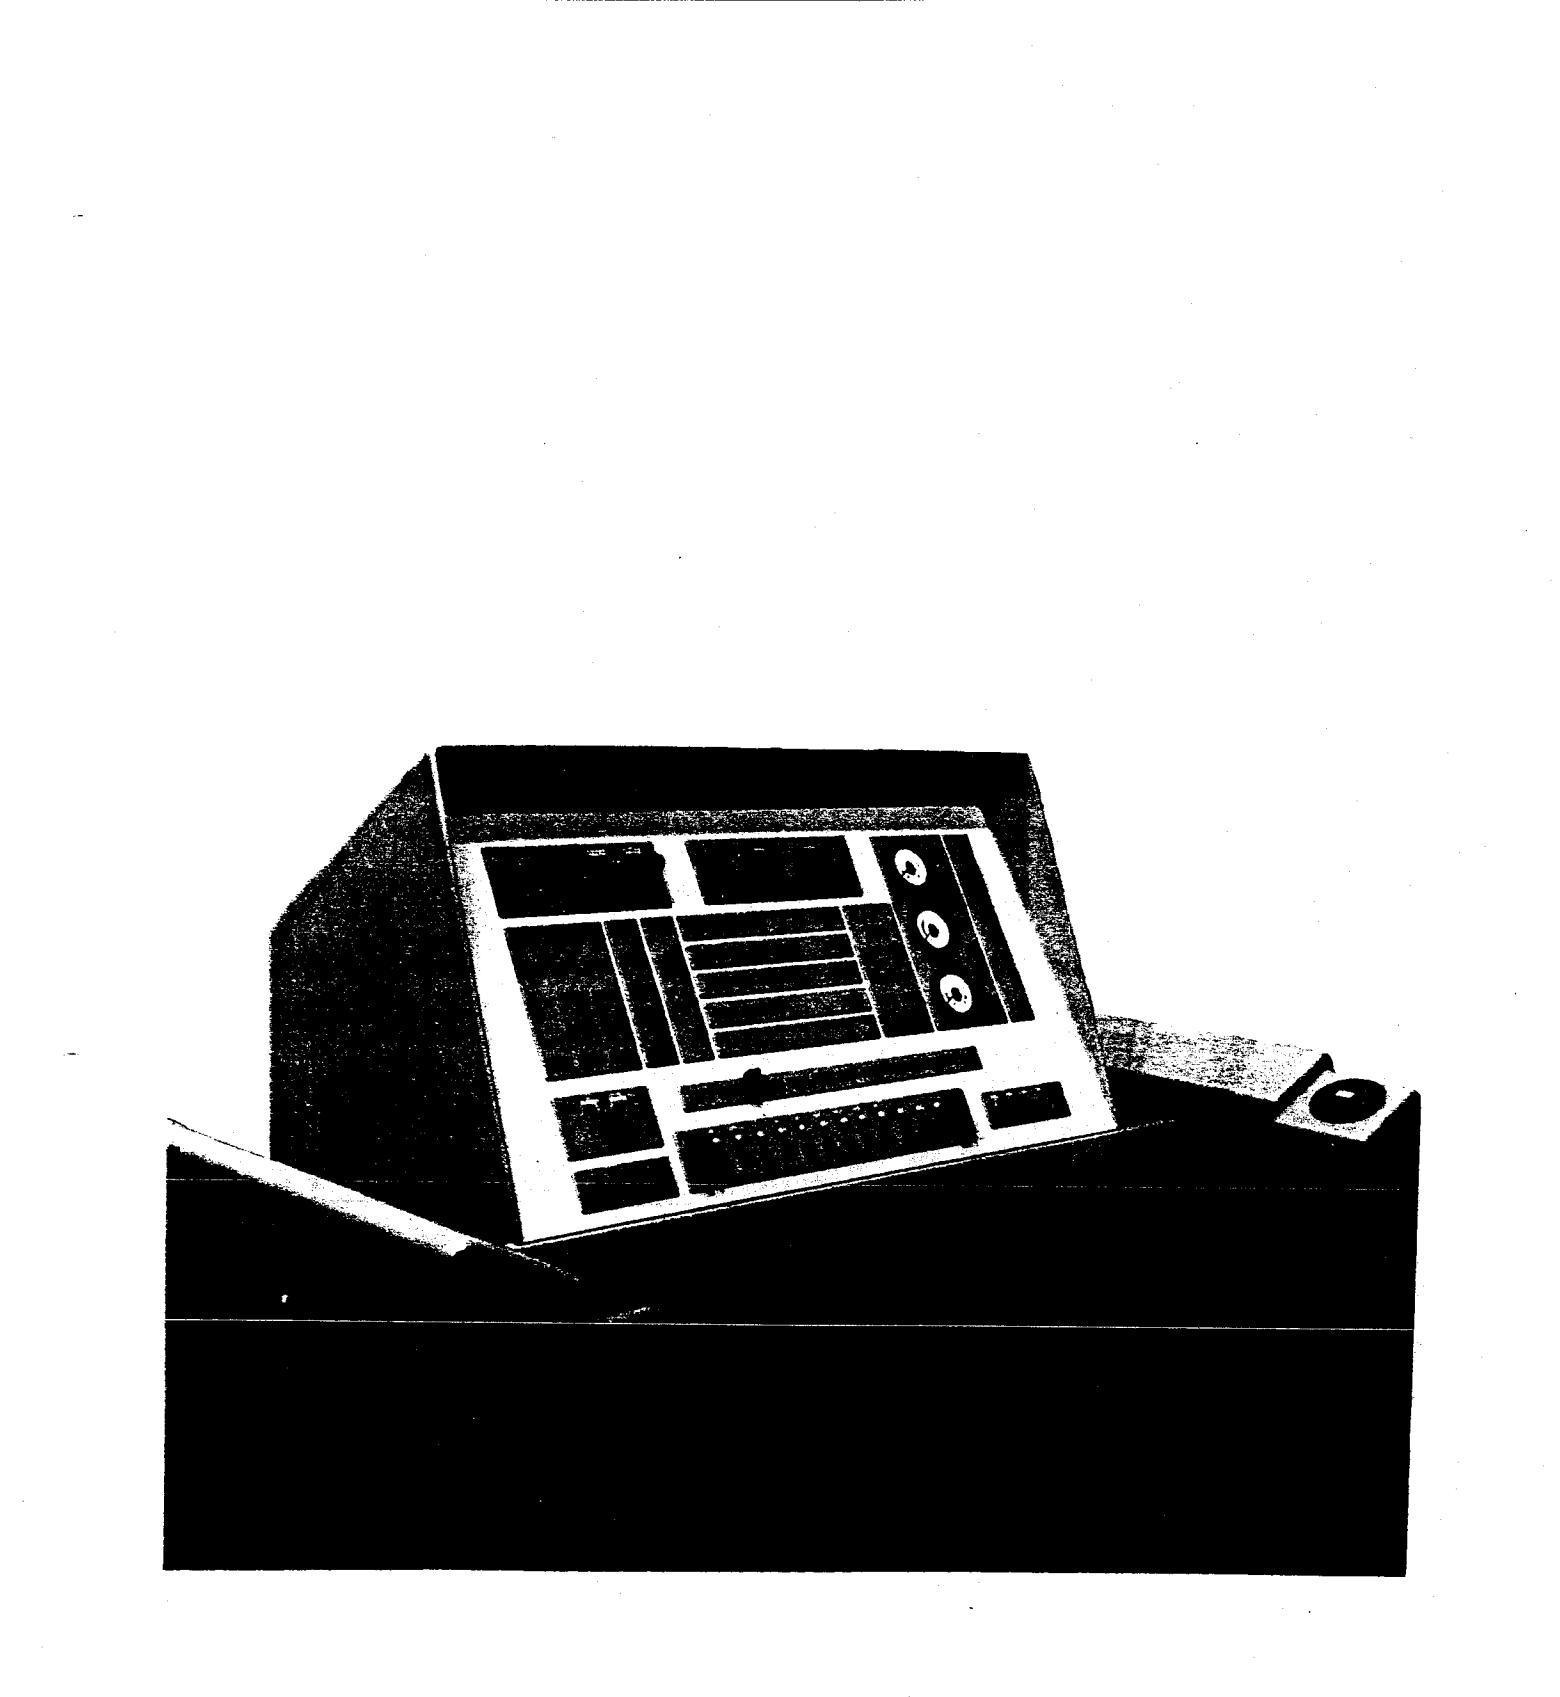
LAUNCH CONTROL CONSOLE

The launch control officer monitors and operates the missile and its ground support equipment from the launch control console located on the lower level of the Launch Control Center (see opposite page). The indicators and controls on the panel show the countdown-ready status of missileborne and silo-mounted systems; pushbuttons are provided for the emergency control of missile tank pressures. In the upper left corner of the panel are guidance system indicators and controls. At the top center of the panel is a digital clock. During a countdown, this clock indicates the time remaining before missile launch. When the ready-for-countdown indicator is green, a countdown can be started by depressing the start button below it. Indicators to the right of this button show the progress of the countdown. When the ready-for-commit indicator turns green, depressing the button to the right of that indicator causes the missile to be raised out of the silo and launched. If a malfunction occurs during a countdown, the sequence can be reversed to the ready-for-countdown point by depressing the start abort button to the right of the precommit indicators. Other controls on the panel include buttons for the launch complex telephone and public address systems.
